## Stucco Moisture Inspection Report

**For the Property Located At:**  
Sample Inspection St.

**Report Prepared Exclusively For:**  
Potential Buyer

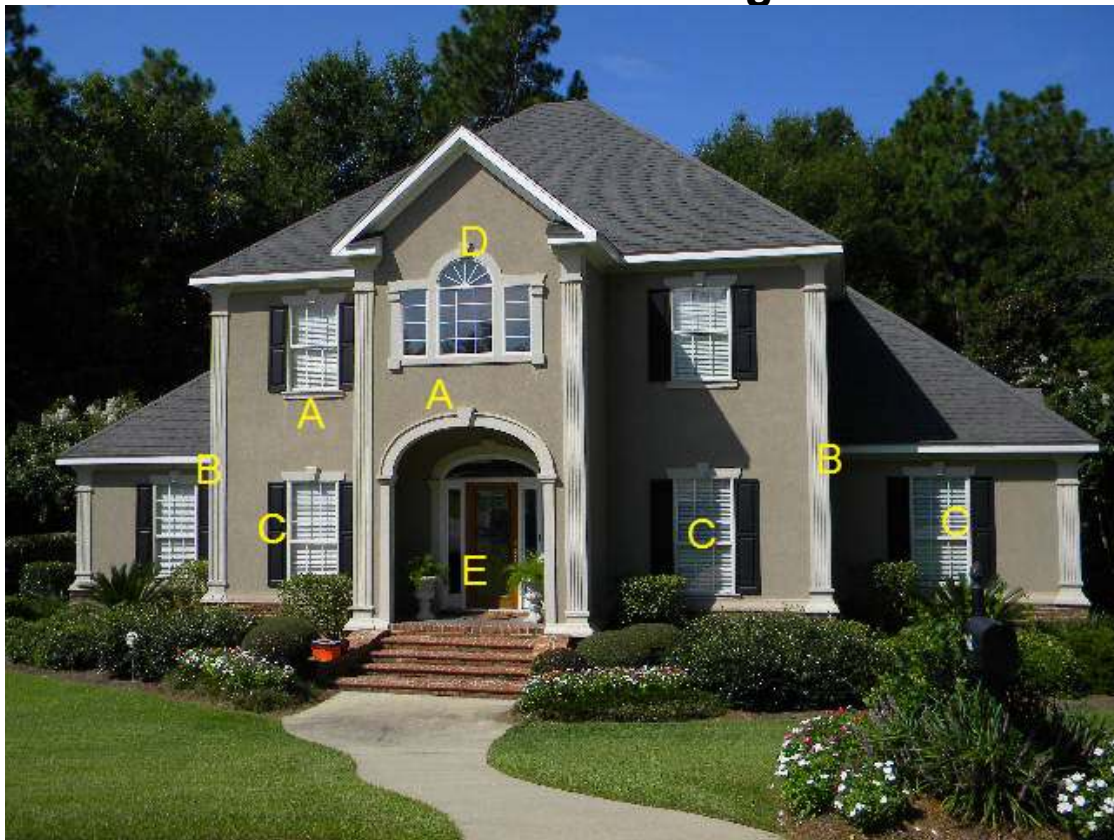
## Front Elevation Page

Item	Item Description	Applies to Entire Bldg	Observations / Comment
A	Efflorescence	No	Some stainage from water run off or migration thru the stucco band sealant will correct.
B	Kickout	No	Kickout flashing is missing and needs to be installed and properly sealed. Soffit termination needs sealed to stucco.
C	Windows	Yes	All window jams and sills need to be sealed to the stucco.
D	Fixed window	Yes	Suggest all fixed windows are sealed glass to frame, frame to frame and perimeters to stucco.
E	Door	No	Suggest front door perimeter sealed to stucco and jams sealed to threshold.

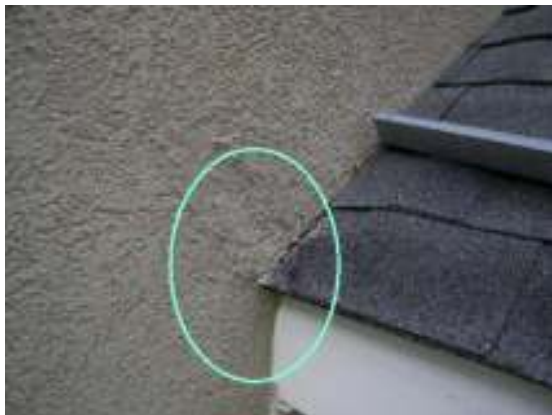
B. Missing kickout flashing detail.

**Kickout flashing-** The improper kick-out / roof terminations need to have a proper flashing installed and sealed to prevent water intrusion through the system at these areas. During the installation of any flashing the immediate area can be inspected for wood rot or damage. Any other roof flashing in the area should also be checked as they sometimes can be a contributing cause. We suggest that the sidewall flashings of the roof be set in roof cement in the areas of kickouts as a preventative measure. These areas need to be addressed as discussed in Cpt 3.4. of reference pages on line.

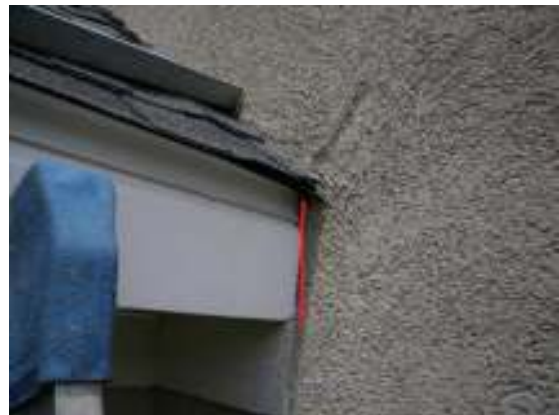
B. Insure soffit sealed to stucco

We suggest all roof /soffit termination are sealed to the stucco as a preventive measure.

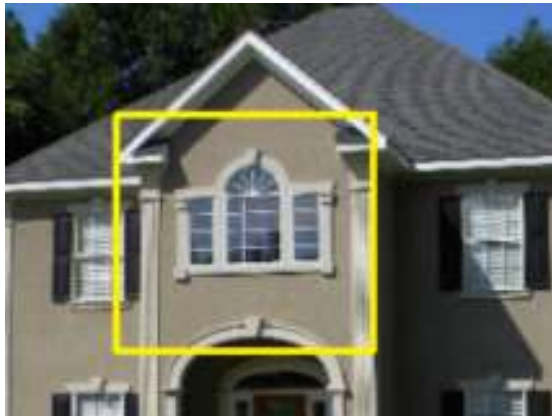
D. fixed window

**Windows-** The window perimeters have never been sealed as well as the mullion joints. These should all be properly sealed ( tooled into place) with a good sealant, preferably Dow Corning 795 or equal silicone sealant. The joint detail is small at the window sills and will need a low modulus sealant to work properly. Other wise new stucco bands would have to be installed. A proper sealant joint can be installed with a skilled applicator. All window miters should be checked and sealed at the bottom corners under the sash.

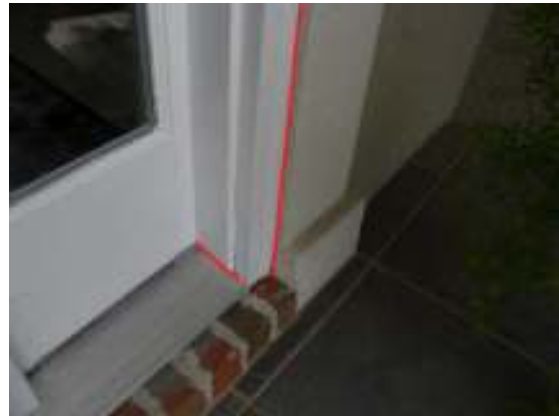
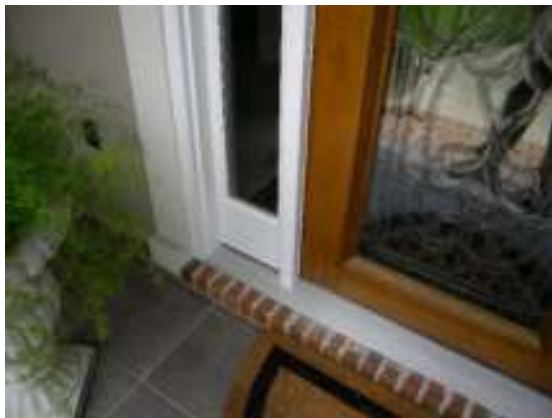
E. Door perimeter sealant

E.

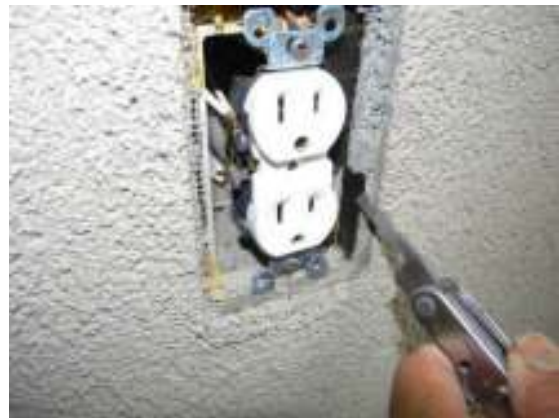
Misc- DEFS stucco applied over felt and OSB sheathing

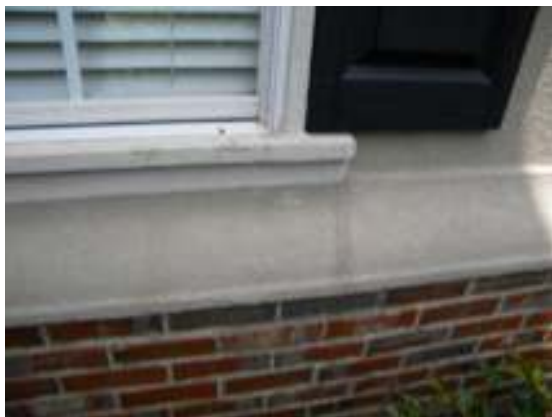
Minor band cracking at a few locations

**Cracks-** A few cracks were noted in the lower stucco shelf band over the brick knee wall. These are minor and pose no threat as they are over the brick/foundation. A repair can be done with a texture patching sealant and painted over with a matching house exterior coating.

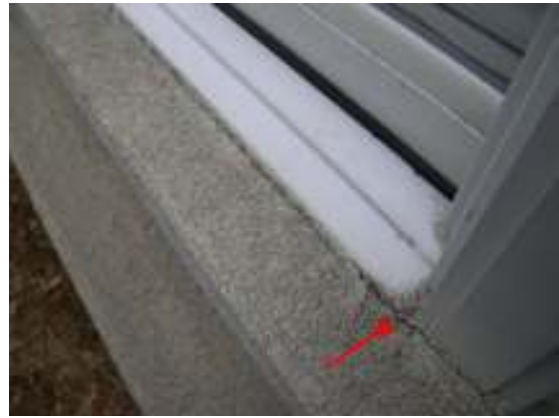
A Water entry points

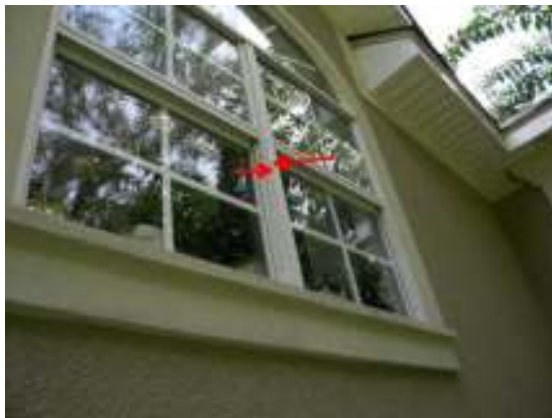
A. Mullion joint also need sealed.

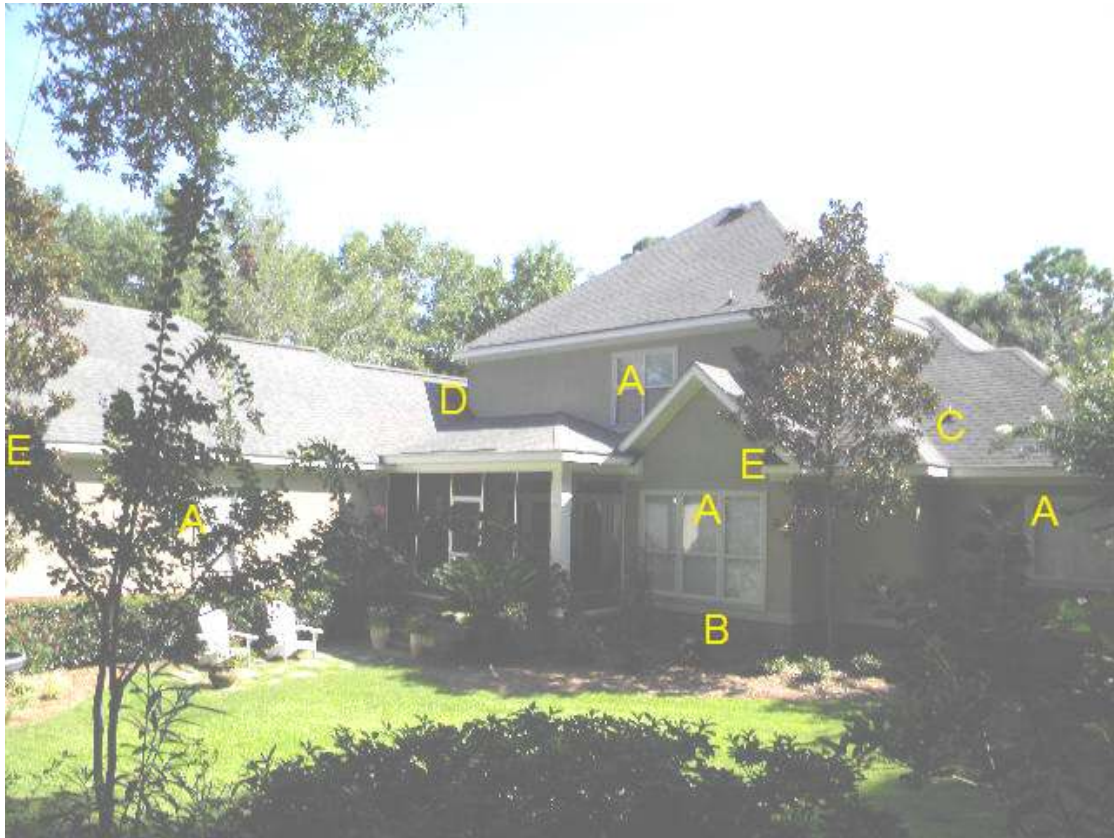
## Rear Elevation

Item	Item Description	Applies to Entire Bldg	Observations / Comment
A	Windows	Yes	All window frames and construction (mullions joints) need to be sealed.
B	Cracks	No	Minor stucco band crack
C	Roof vent boots	No	Vent boots lifted, suggest refastening to roof and sealing.
D	Roof valley	No	Inspection of attic space below valley did not reveal any visible leak areas. No photo!
E.	Roof Terminations	Yes	Seal all soffit to stucco transitions.

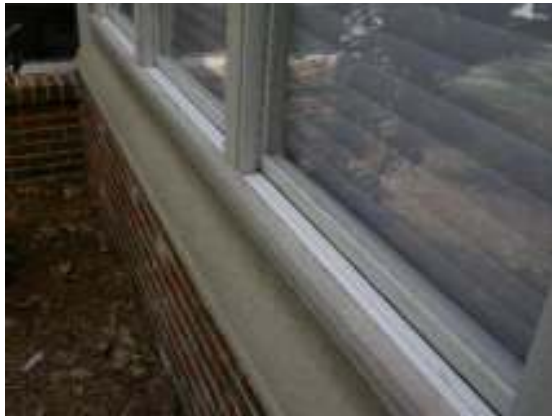
A. Seal all window perimeters

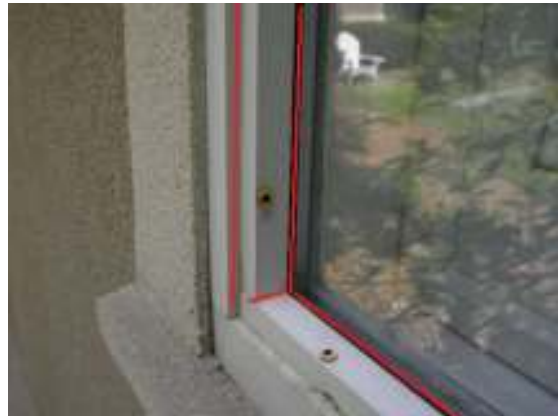
A This type of fixed glass window should be sealed (wet glazed)

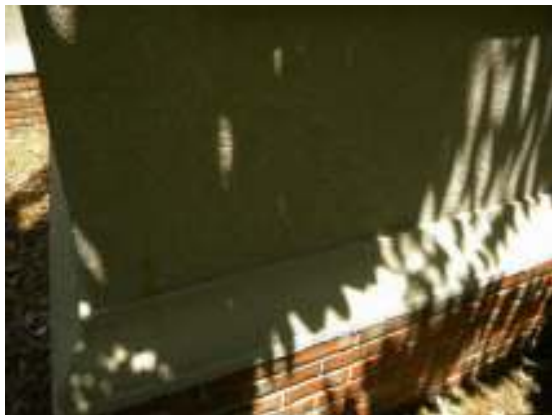
B. Random minor cracks in the stucco cap band

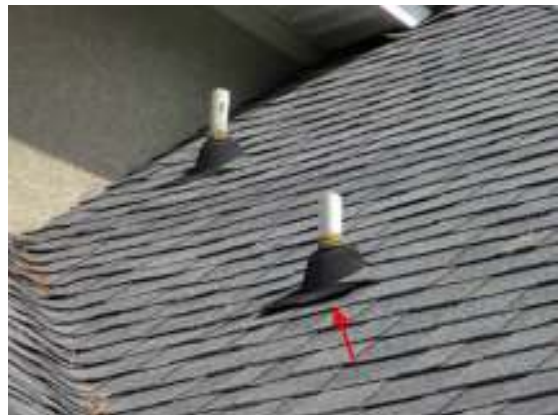
C. Vent boots here need fastened.

**Roof vents boots-** A couple of vent boots appeared to be lifting (see report) and should be re attached and sealed in place.

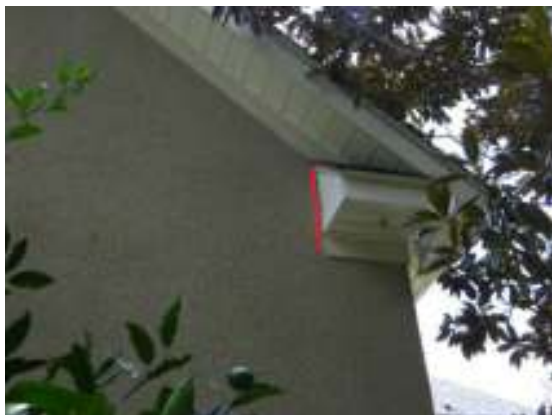
E. Seal roof terminations

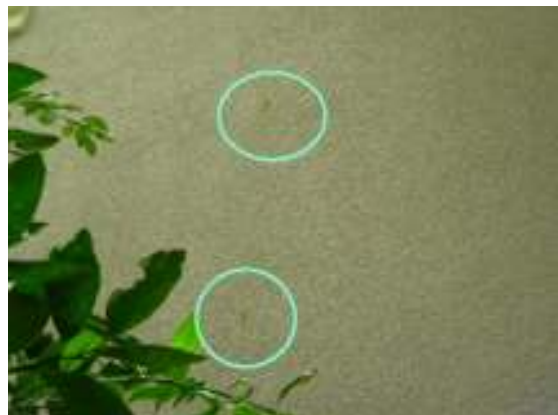
Misc. Some rust aggregate in stucco finish thru out the system.

**Rust and efflorescence stains** - Some areas noted where the finish has some 'rusting' aggregates as shown in close-up photo. This problem is caused by iron aggregates being left in the sand when the finish coating is manufactured. To correct the offending aggregate must be 'picked out' and the area cleaned with appropriate rust and efflorescence remover. With extreme cases the system needs to be coated to help prevent additional rusting to continue.

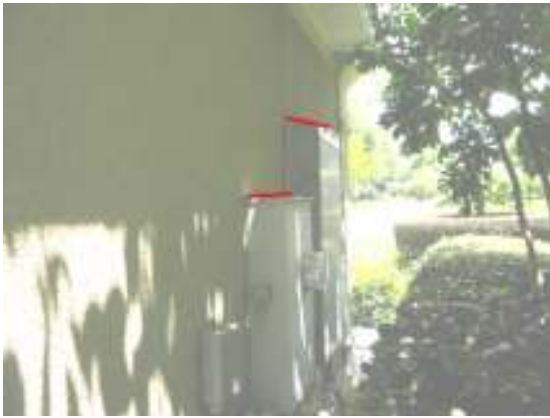
A. Insure all utility fixtures are sealed.

**Utility's-** All wall attached or penetrating utility's should be sealed at the stucco, most were but a few were observed unsealed.
