## Stucco Moisture Inspection Report

**For the Property Located At:**  
Sample Inspection St.

**Report Prepared Exclusively For:**  
Potential Buyer

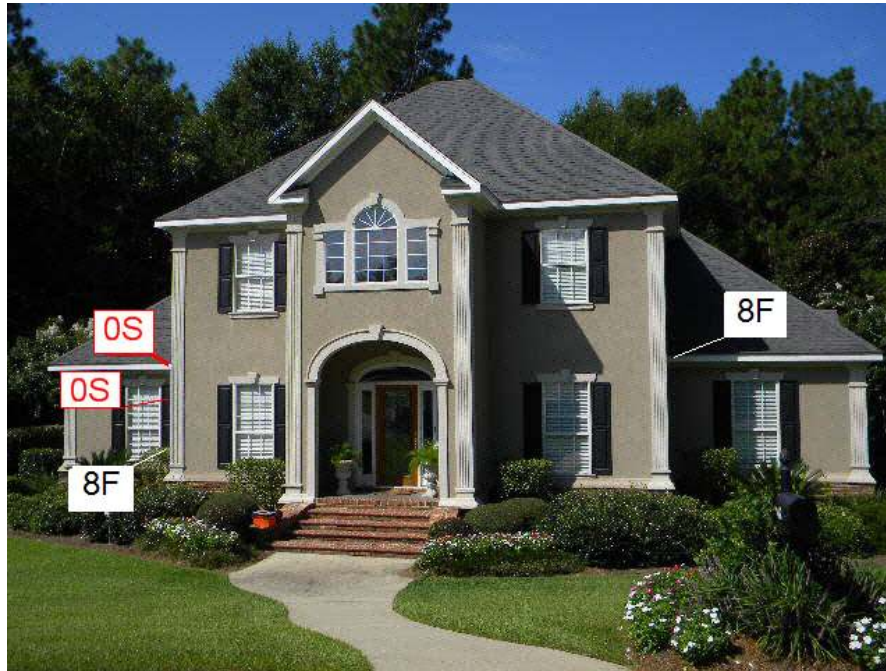
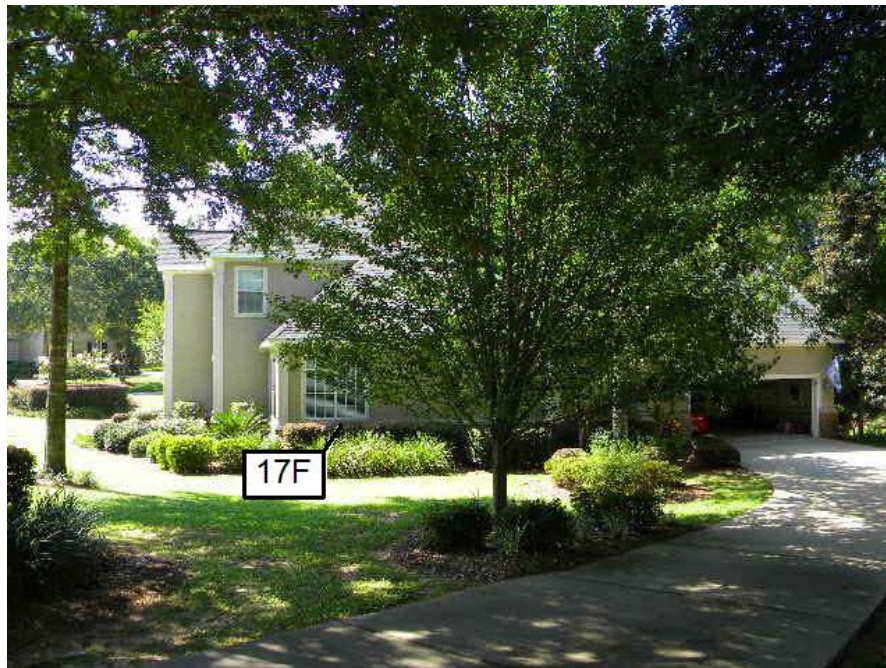
**Probe Readings:** Shown in approximate area where probe was made. **Numbers > 20 are considered high**  
**Substrate Resistance:** F=Firm (good) S=Soft (possible damage) SS=Surface Soft (possible minor damage)  
**Green Rectangles:** High Interior scan **High or Soft Probe readings are shown in RED**

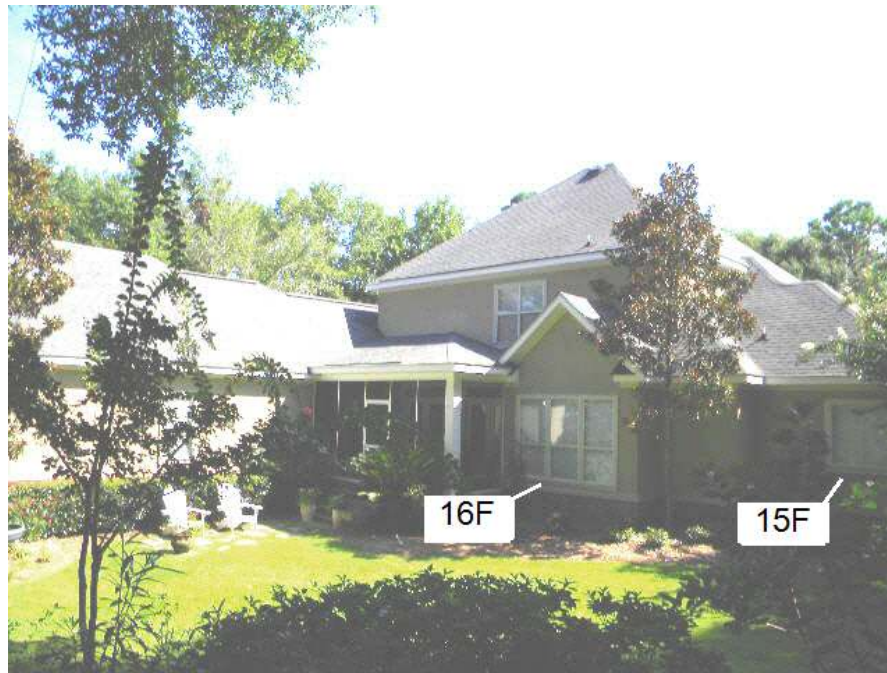
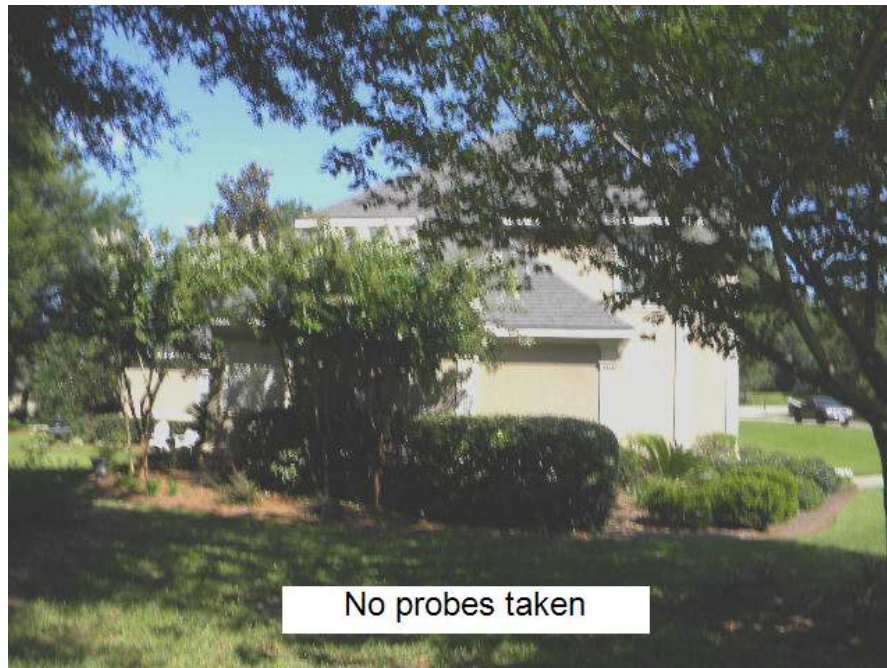
**Probe Readings:** Shown in approximate area where probe was made. **Numbers > 20 are considered high**  
**Substrate Resistance:** F=Firm (good) S=Soft (possible damage) SS=Surface Soft (possible minor damage)  
**Green Rectangles:** High Interior scan **High or Soft Probe readings are shown in RED**

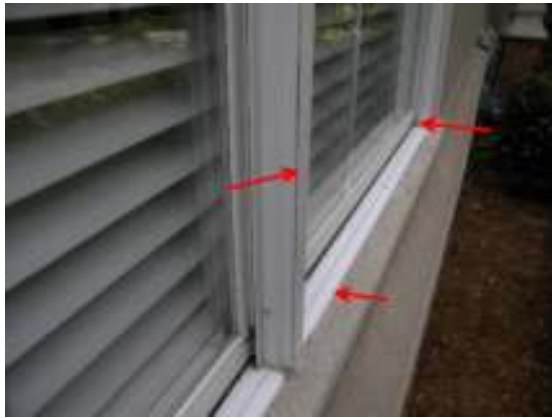
A

A. Mullion joint also need sealed.

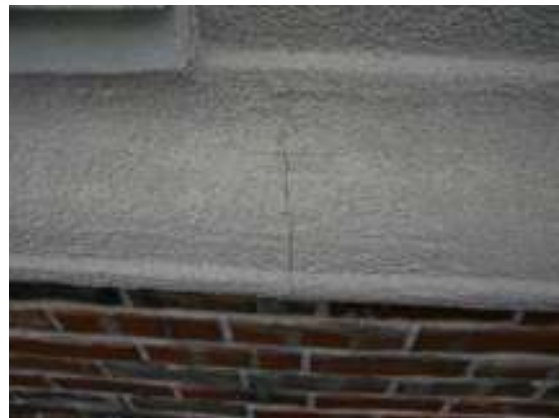
B. Random minor cracks in the stucco cap band
